THE UNITED STATES  
STRATEGIC BOMBING SURVEY

SUBMARINE ASSEMBLY  
SHELTER  
FARGE, GERMANY

MUNITIONS DIVISION

**SUBMARINE ASSEMBLY SHELTER AT FARGE**

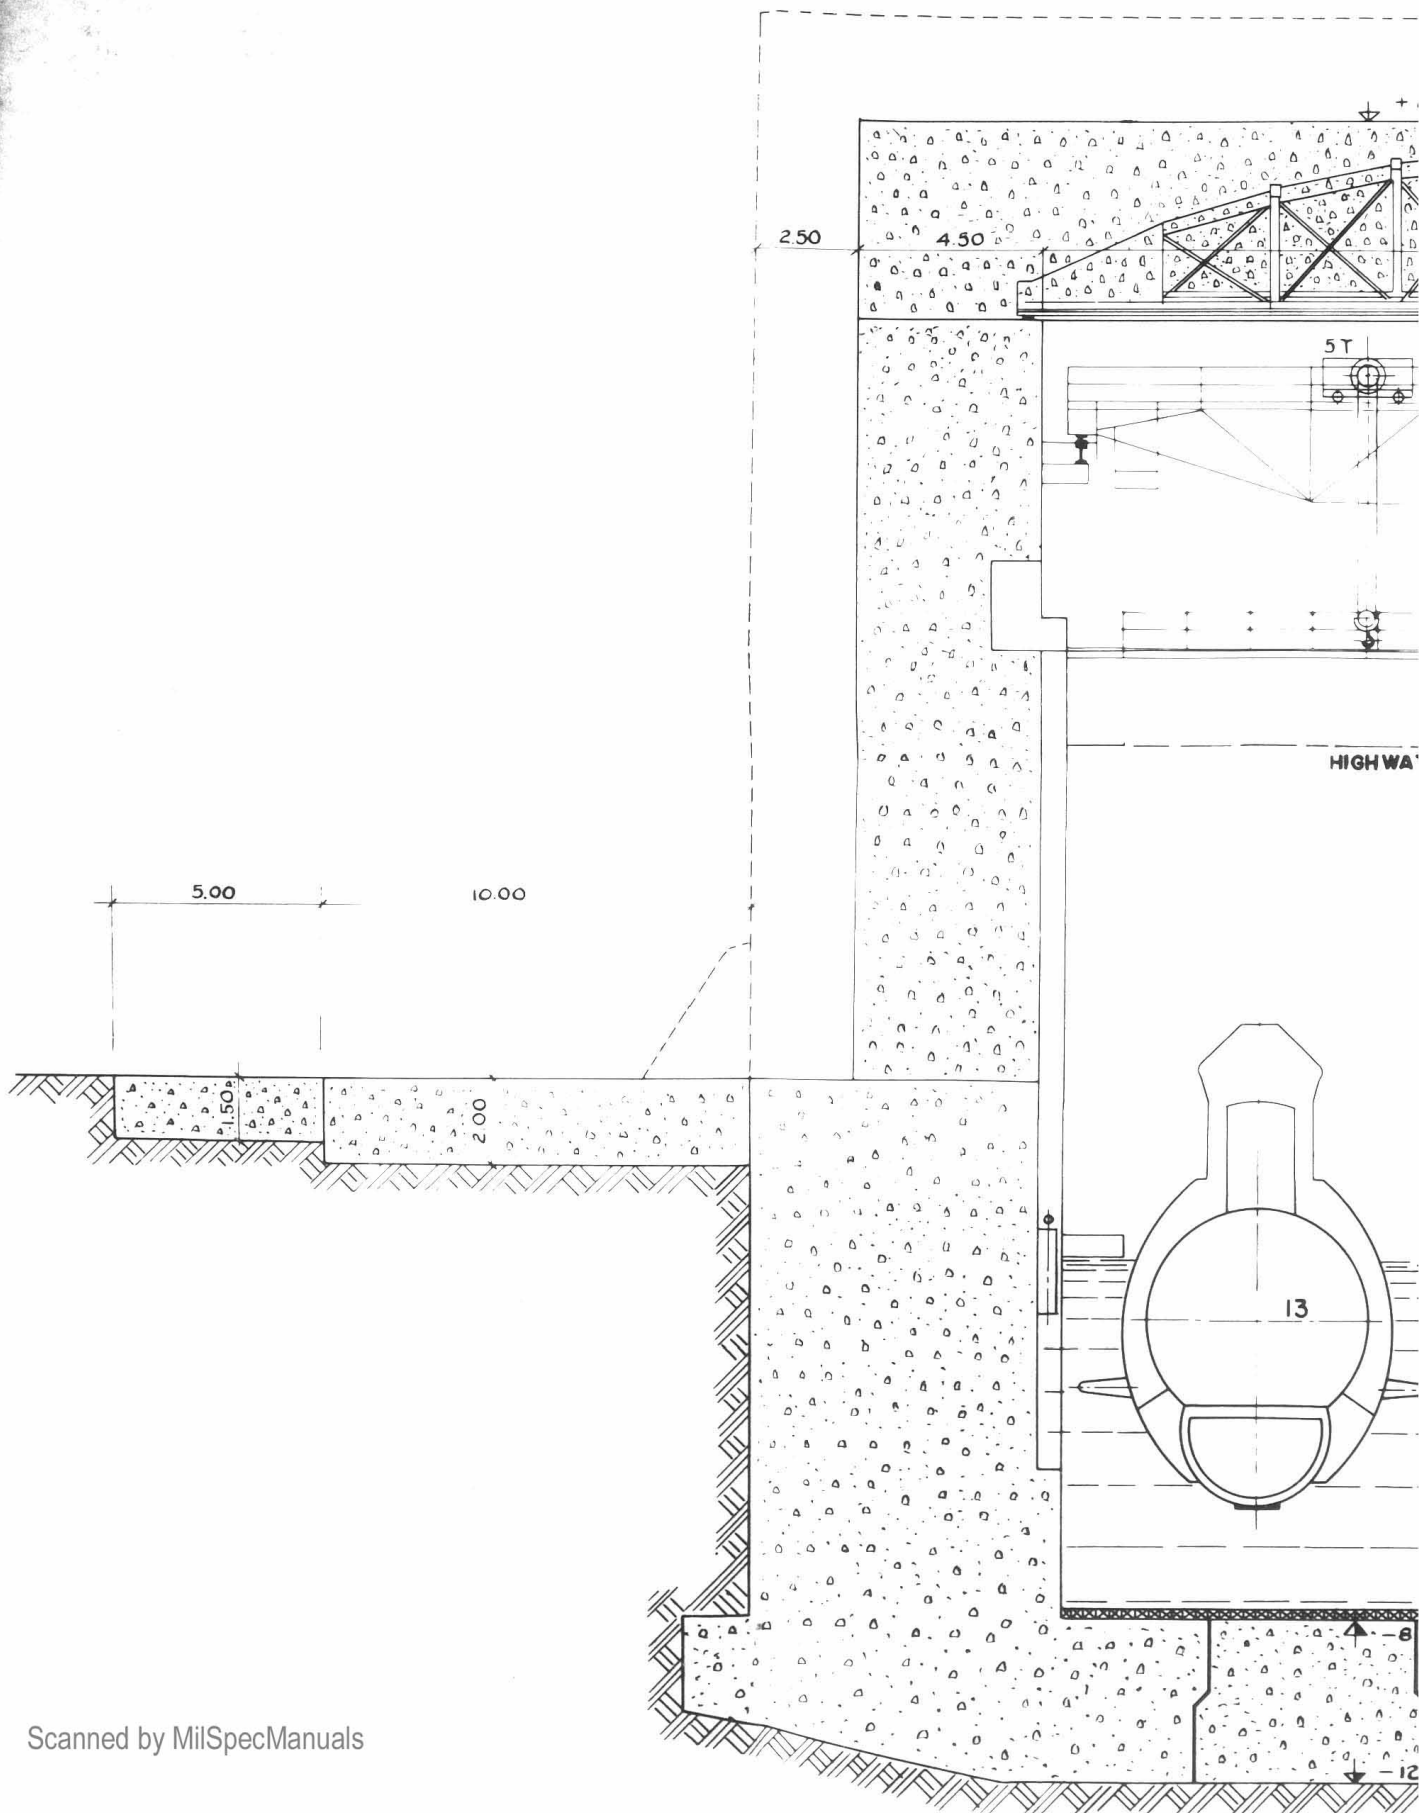
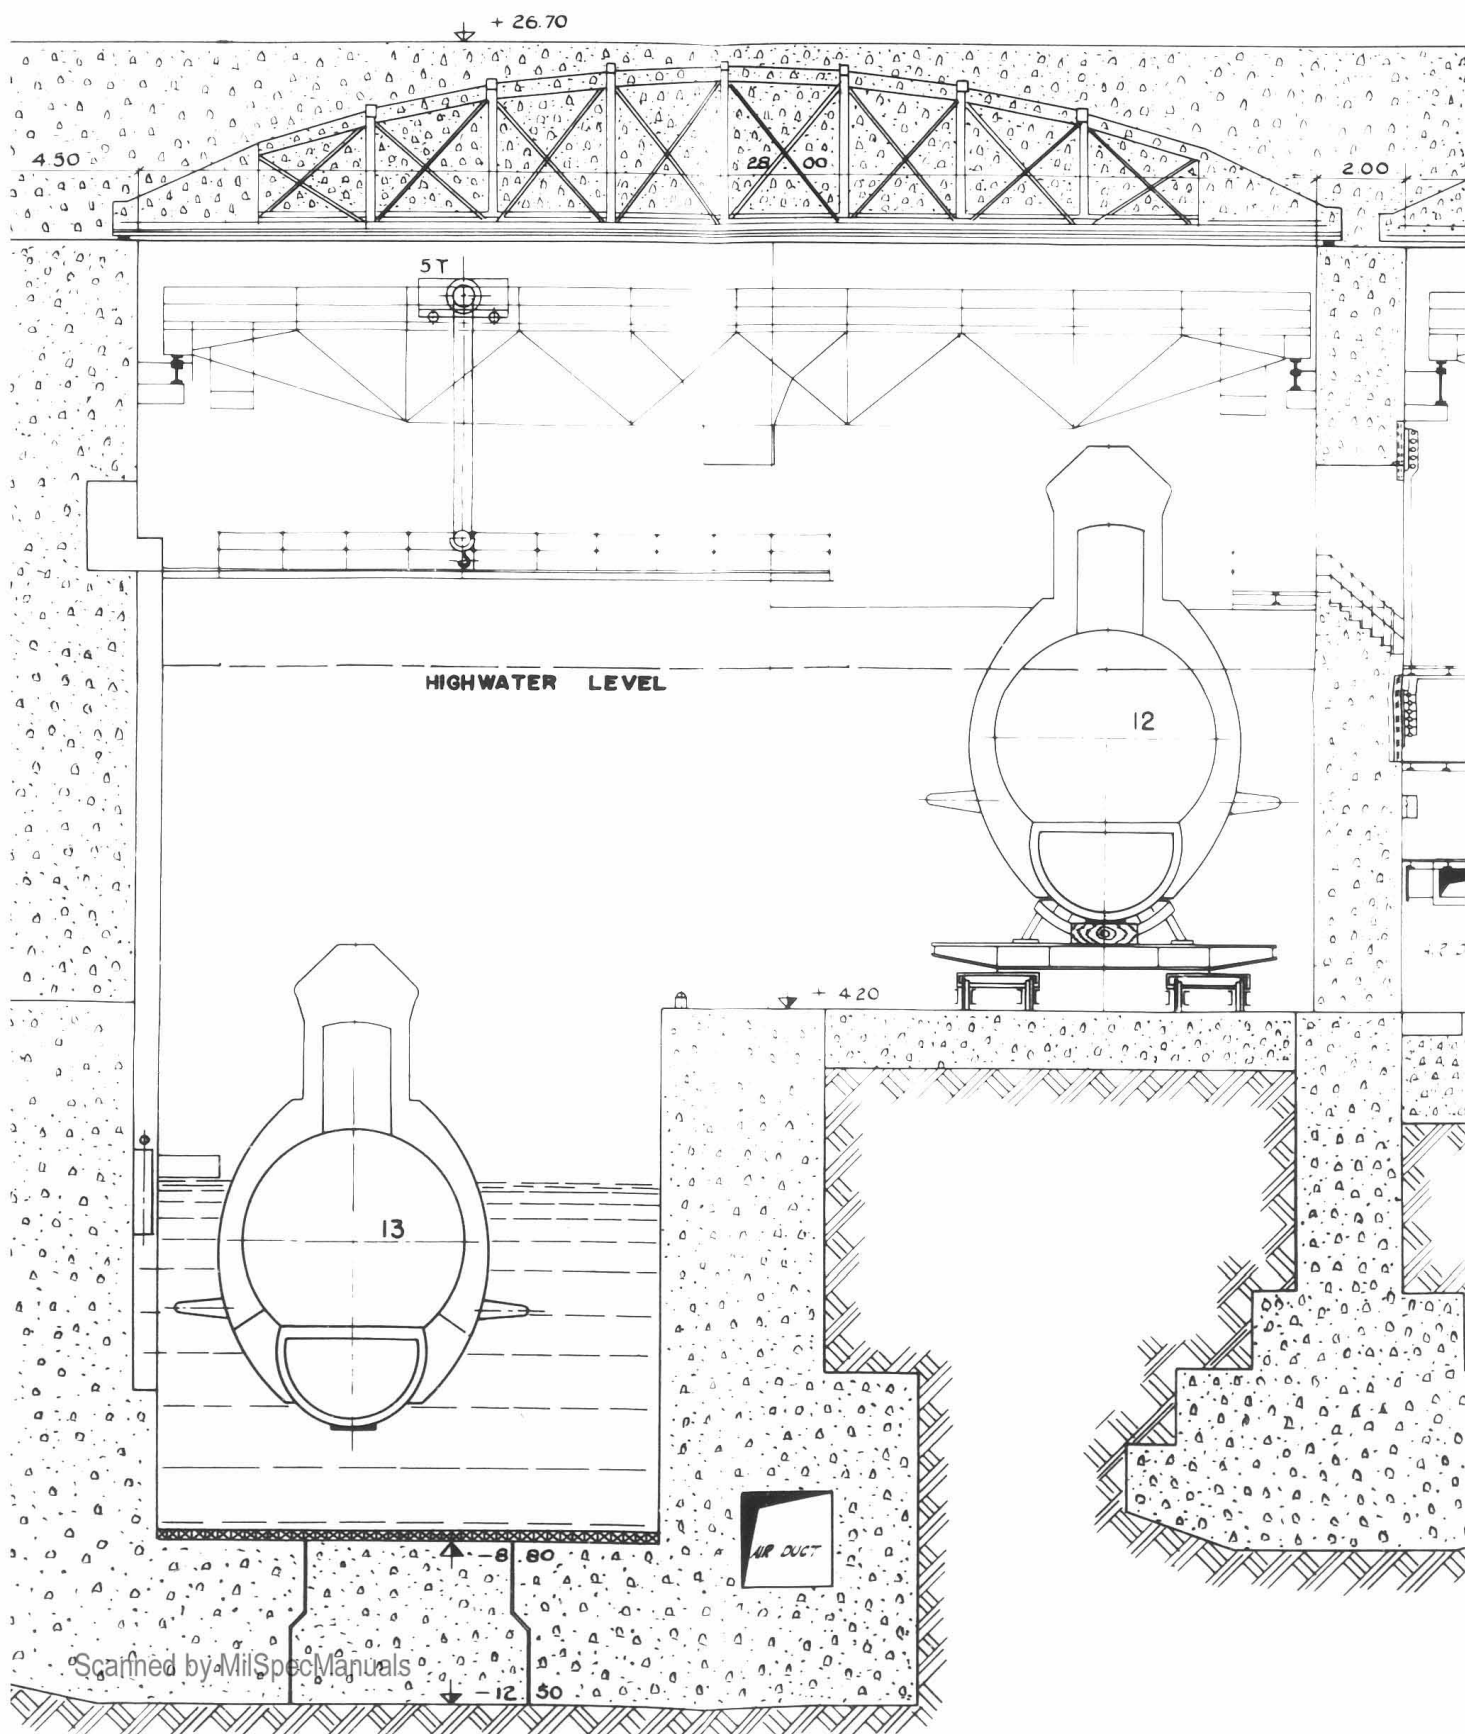
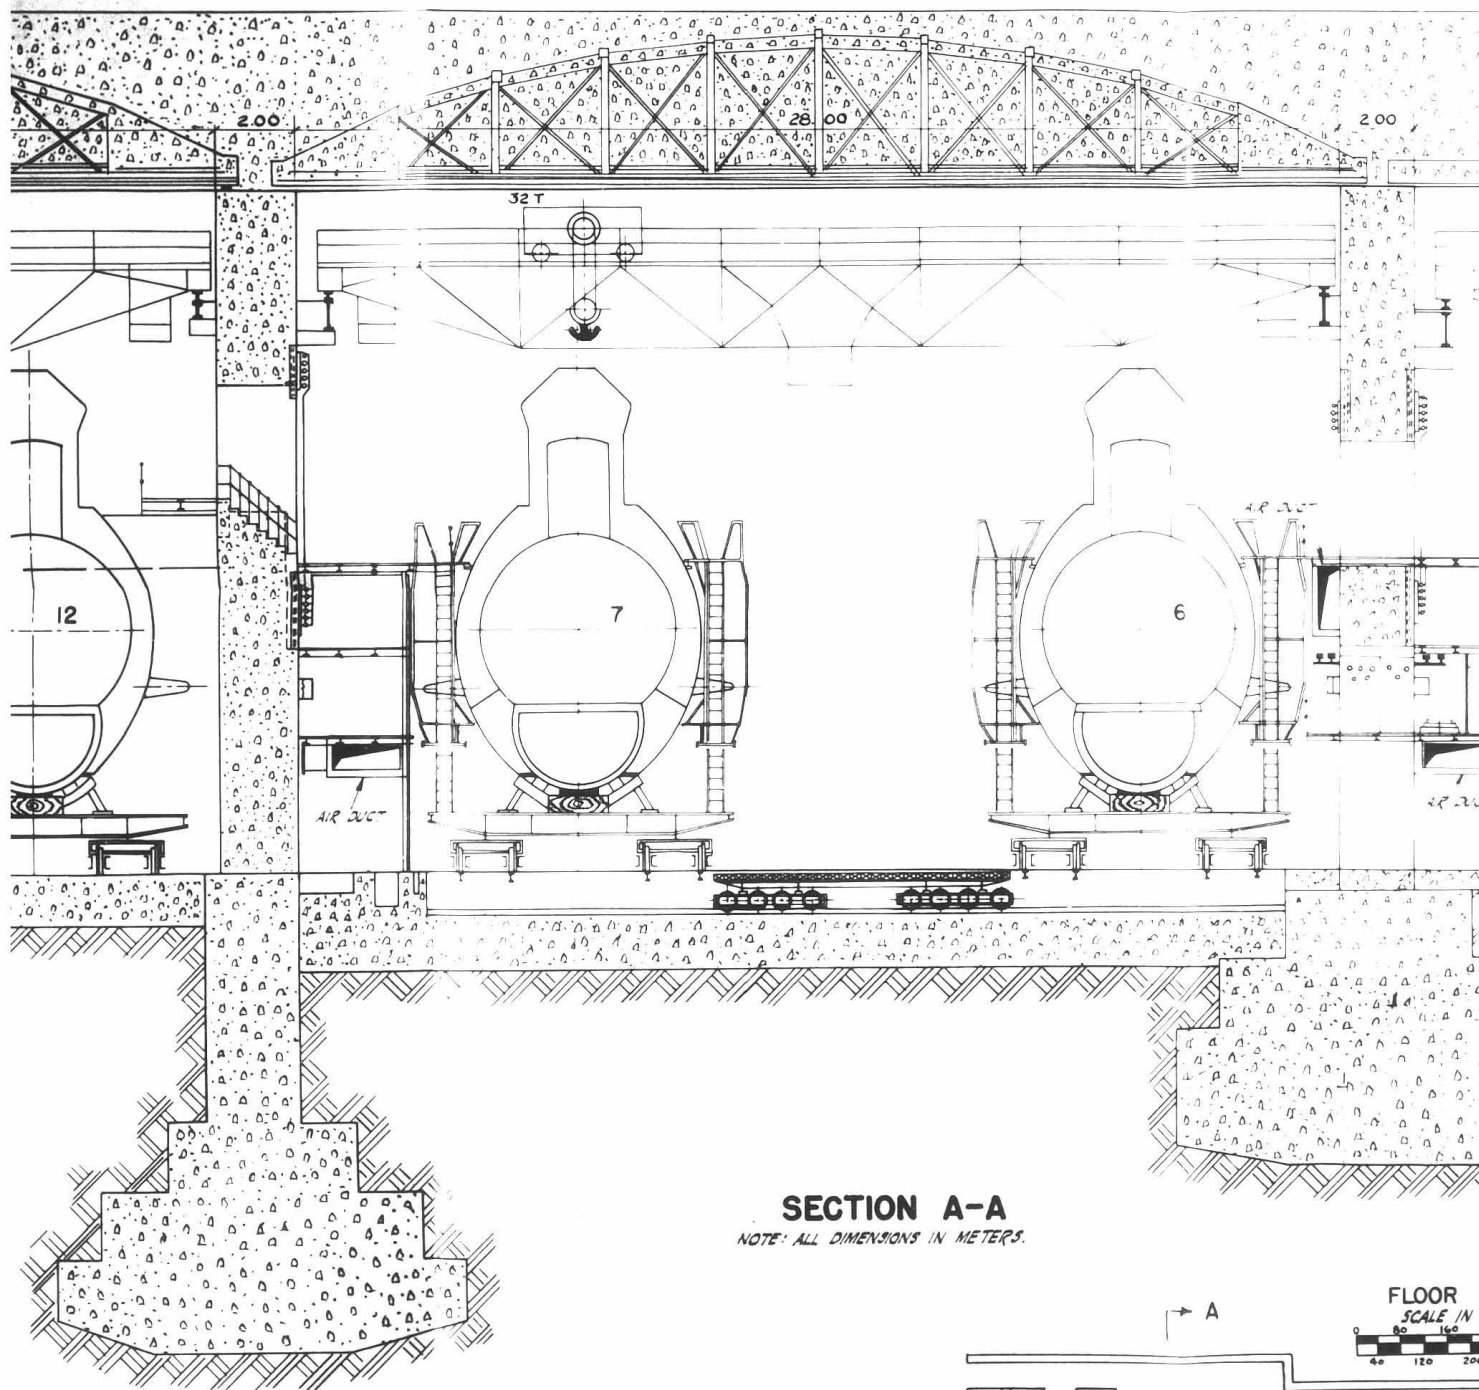
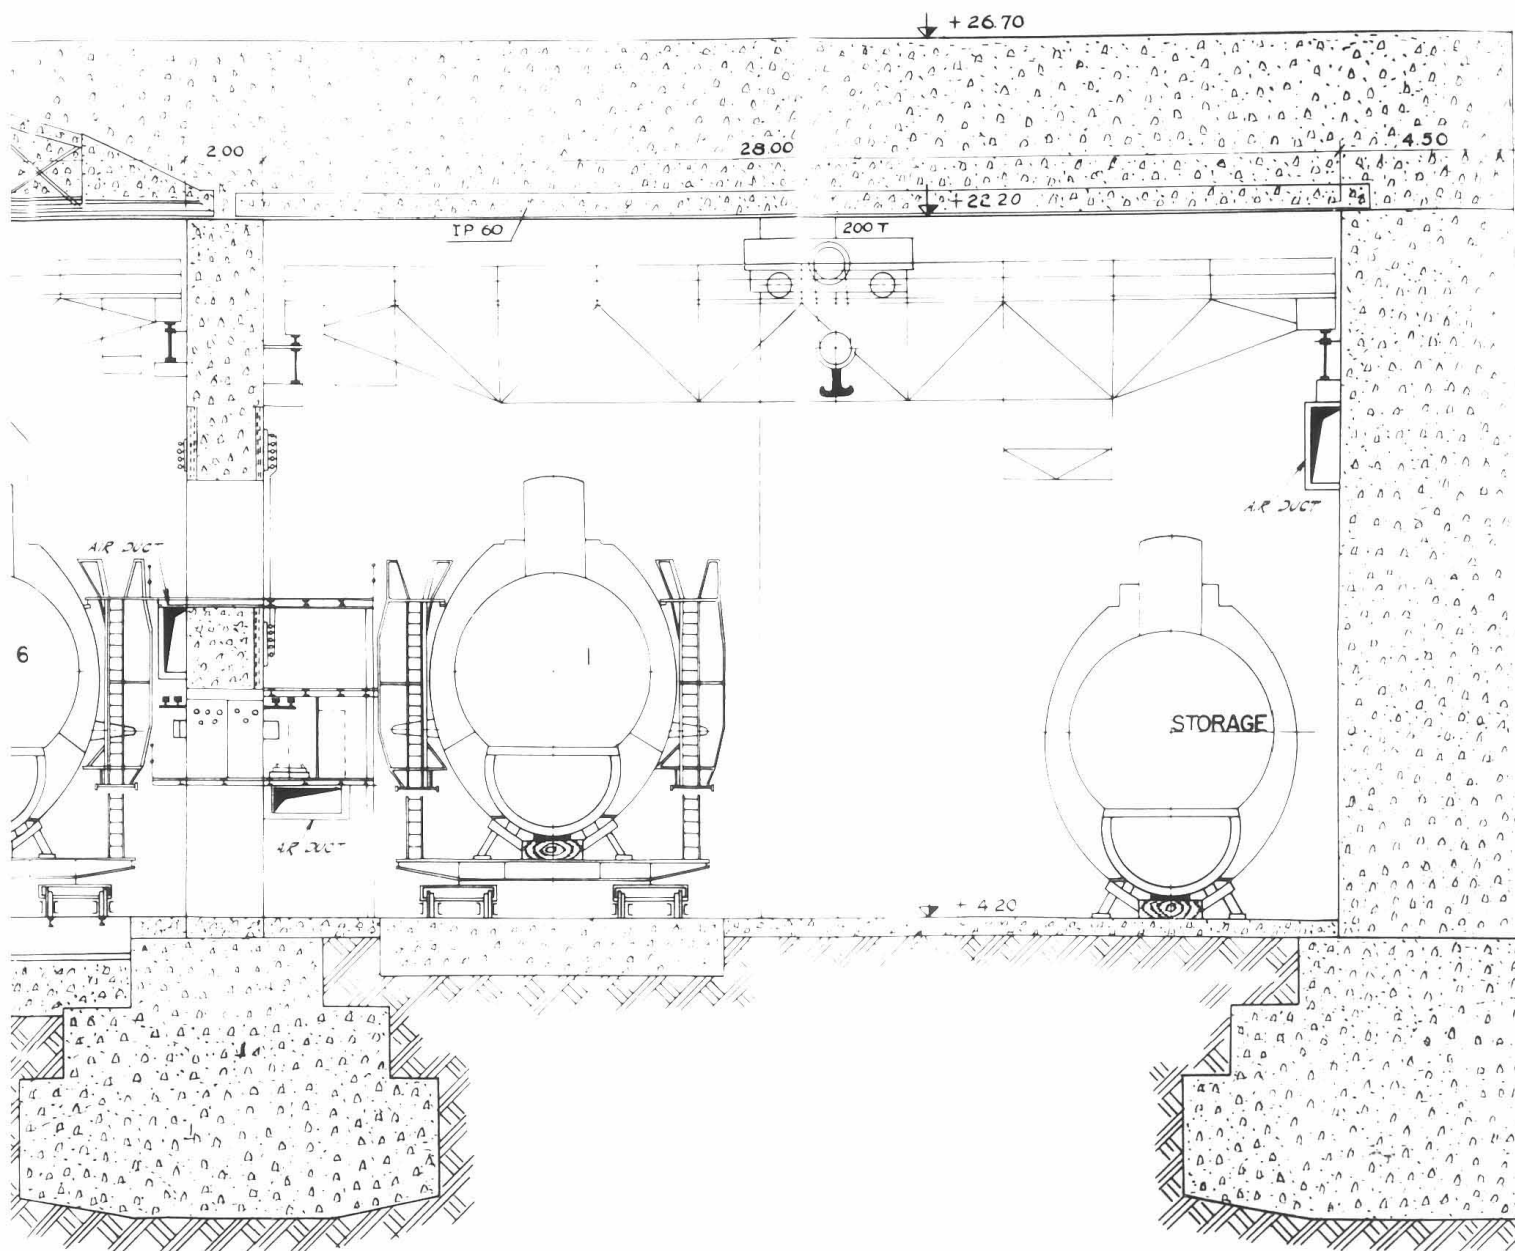
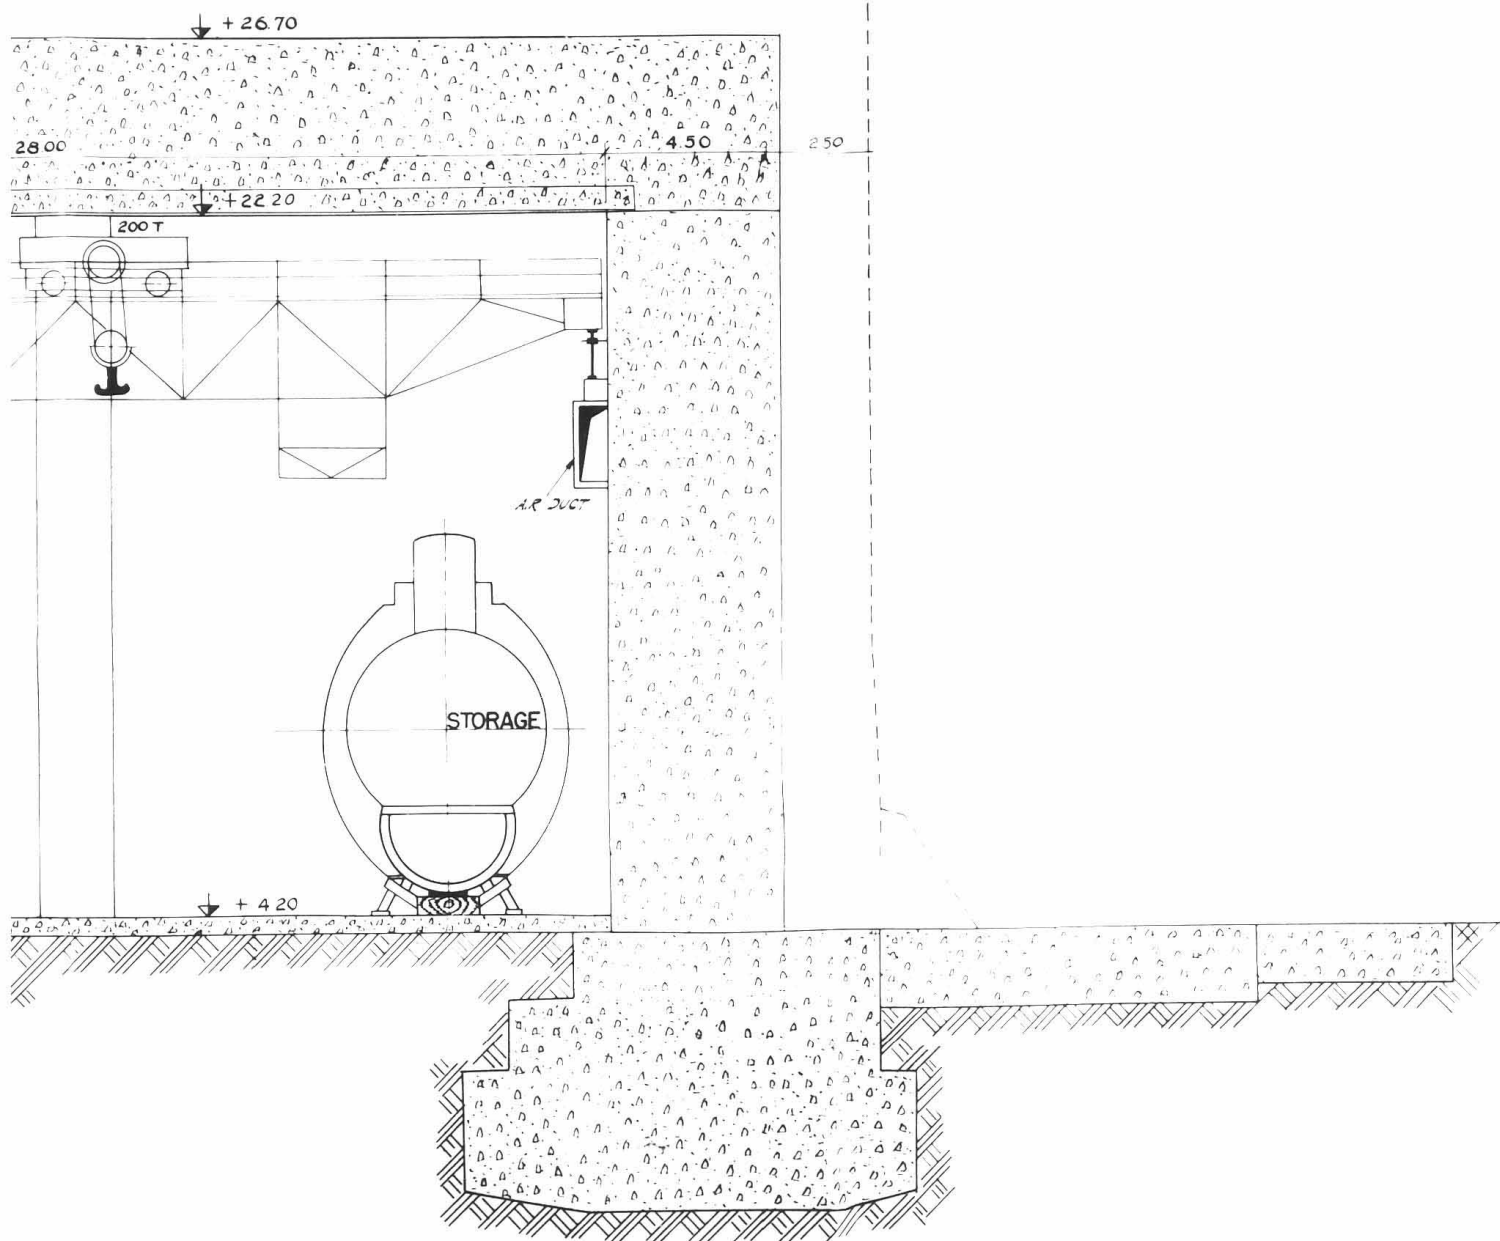
**TRANSVERSE SECTION**

11. As can be seen from Exhibits B, C and D, VALENTIN was a very simply designed building. Its foundation consists of longitudinal monolithic concrete foundations supporting the outer walls and arched partitions. The design was based on the assumption that the soil would withstand a pressure of 114 pounds per square inch, which is very high for ground consisting of approximately 36 feet of fine quartz sand, with a small silt and mixture lying on a very thick strata of dense clay. The consulting engineers were prepared for a permanent settling of the building of 12 inches. In reality a 9.5-inch settling was recorded.

13. The roofs consist of a slab which is no doubt the most interesting feature of this colossal building. At first it was designed to be 14 feet, nine inches. For the reason stated above, it was decided to increase the thickness to 23 feet, and work had begun in this direction. Experience, however, having shown that 23 feet might not be proof against future bomb developments, it was planned to increase the thickness of the roof slab by another nine feet, nine inches to a total of 32 feet, nine inches. In order to save work and material, it was decided to use self-supporting shuttering. Pre-stressed arched trusses were designed for this purpose. (Photos 2 and 12) These trusses were precast on a specially constructed site (Photo 3), then carried by rail to the building and installed in position close to each other. In view of the difficulty in handling such large items, gaps of from one and a half to three inches wide remained between the three-foot wide bases of the arches. After grouting these gaps, a spiral reinforcement was placed between these trusses, and concrete was pumped from the mixers on the ground to a boosting pump substation on the roof. From there the concrete could be pumped to any place on the roof where it was poured to a depth of 14 feet nine inches, superposed

on the arched trusses. This depth represents the maximum weight these trusses could carry. Even at that rate the live-load amounted to 5,000 pounds per foot-run of one truss. After the concrete had set, an additional layer of eight feet, three inches of monolithic concrete was added on top of the original slab. The pouring of the concrete was continuous, with three shifts and up to 2,000 men per shift.

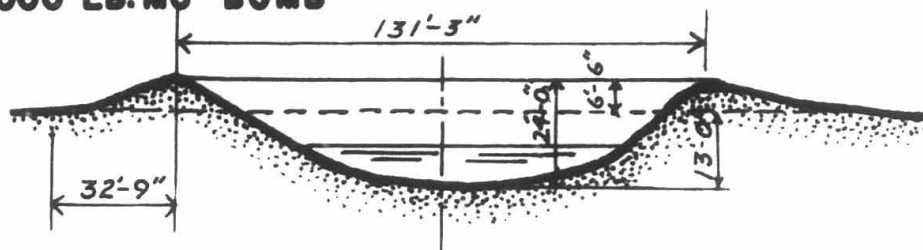
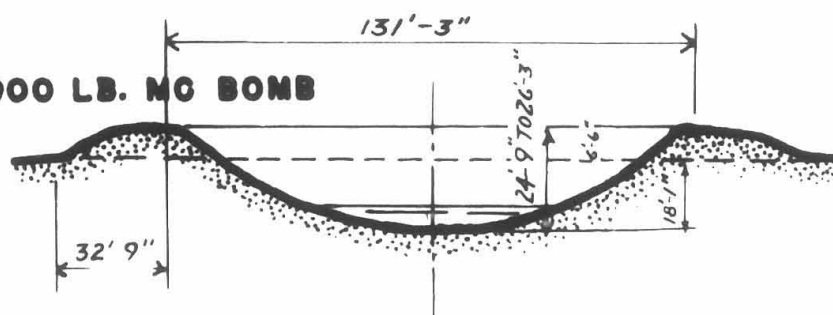
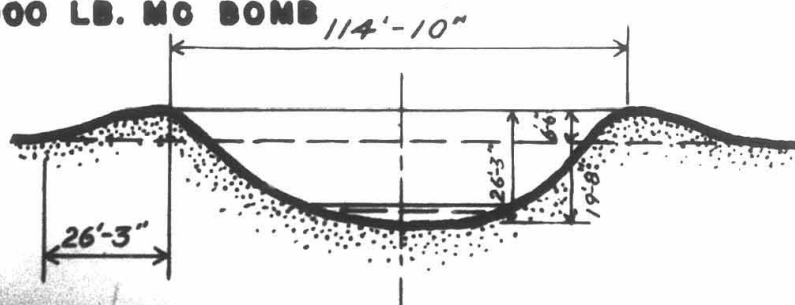
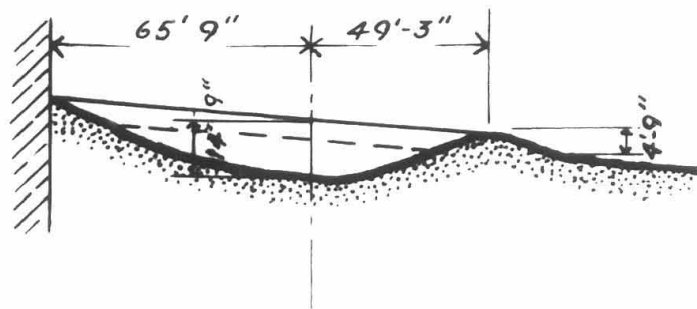
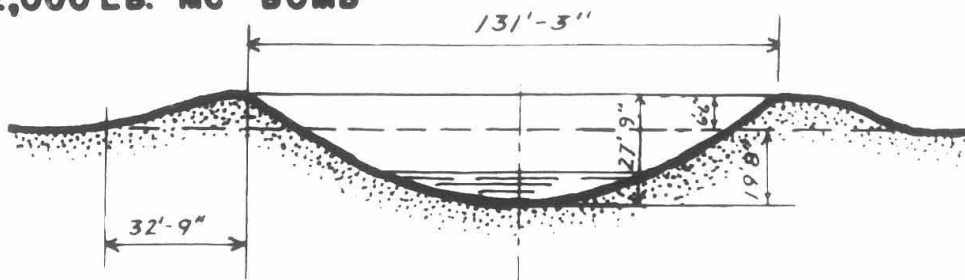
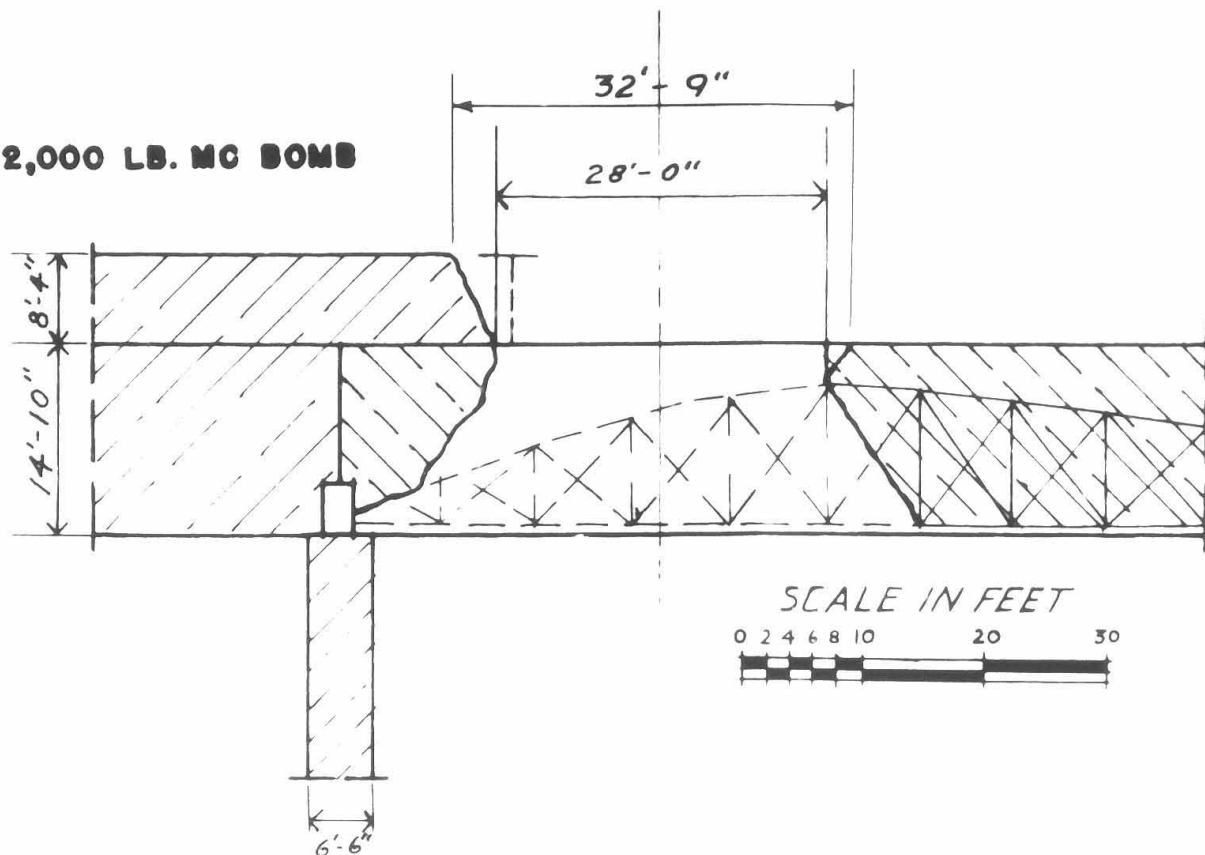
**BOMB CRATER PROFILES**

5. The two hits scored with the 10-ton bomb struck that portion of the roof which was only 14 feet, nine inches thick, and penetrated approximately eight feet, the force of the explosion causing the breaks through the roof. The thickness of the roof proved the building immune against interior explosions since no perforation resulted. In all probability, had the roof been 23 feet thick overall, it would have been entirely bombproof.

b. The bombs penetrated some six to eight feet before detonating, the center of the explosion being practically on the surface of the slab, as clearly shown by fragmentation marks on the wall of the periscope testing superstructure opposite the eight feet, three inches step, which were only four inches above the upper surface of the slab.

① 22,000 LB. MC BOMB

② 22,000 LB. MC BOMB

⑦ 12,000 LB. MC BOMB

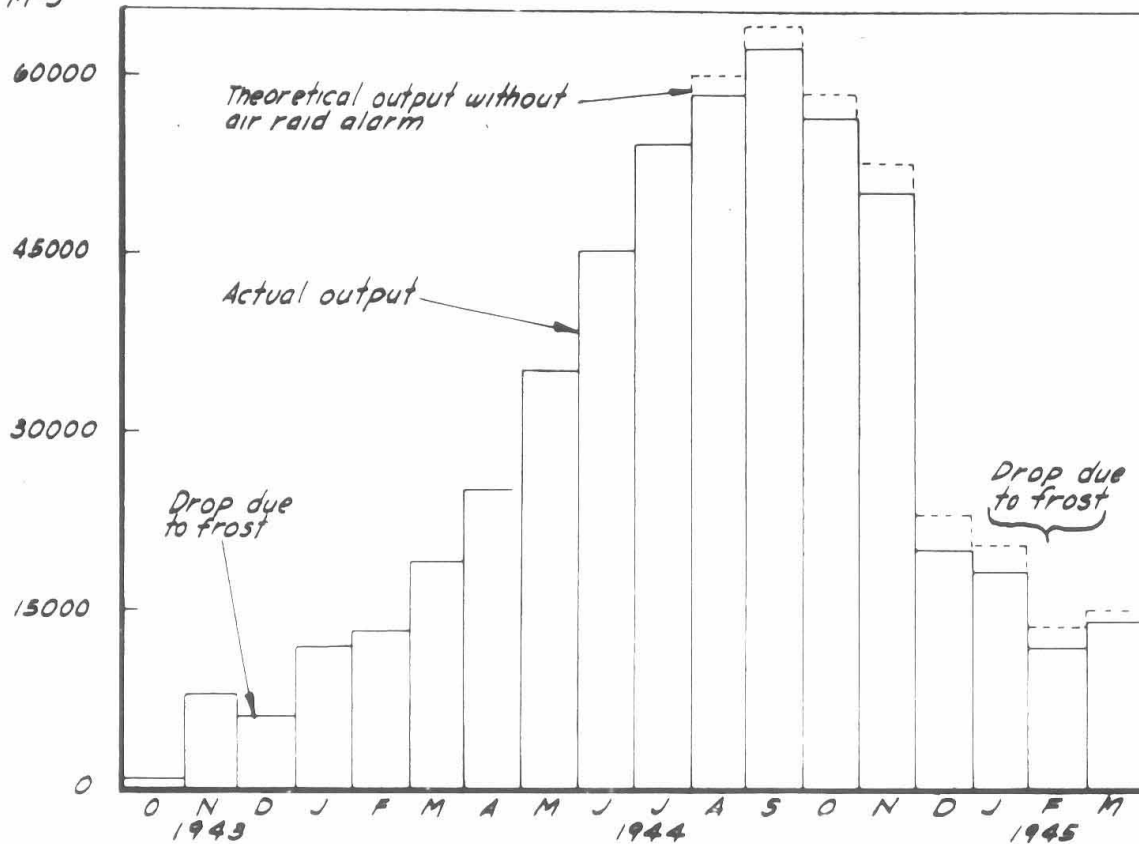
EXHIBIT 'F'  
M-3MONTHLY CONSTRUCTION PROGRESS  
CONCRETE POURED EACH MONTH

4. Heavy structures such as VALENTIN, with a 23 foot slab, are unlikely to be seriously damaged by the bomb, or rocket assisted missile, used.
5. Construction delay, insofar as the building schedule is concerned, is fully illustrated by Exhibits F and G showing how air raid warnings and raids slowed down the production and pouring of concrete.
